[Docket No. 96-CE-46-AD; Amendment 39-9884; AD 97-01-13]

Airworthiness Directives; Cessna Aircraft Company 100, 200, 300, and 400 Series Airplanes

#### **97-01-13 CESSNA AIRCRAFT COMPANY:** Amendment 39-9884; Docket No. 96-CE-46-AD.

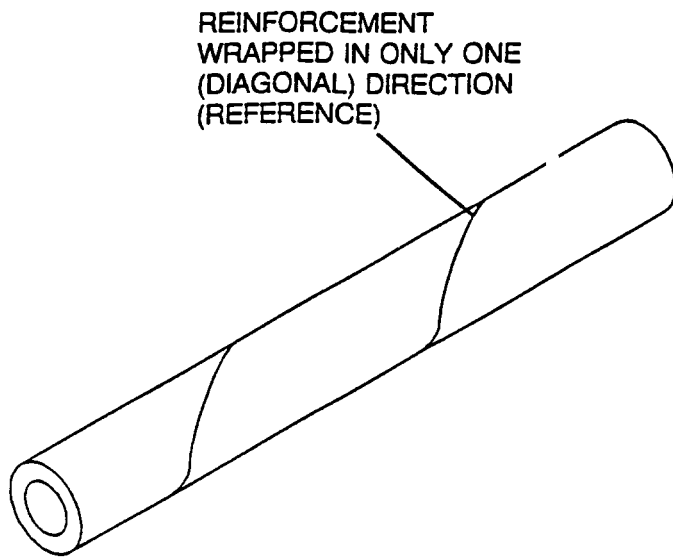
AD 97-01-13  
Figure 1

The FAA has recently received several incident reports of fuel flow blockage to the engines of certain Cessna 208 series airplanes. Examination of the Cessna part number (P/N) S51-10 rubber hoses installed on these airplanes revealed a deterioration to the point of delamination of the inner tube from the external wrap. This rubber hose is utilized on fuel, oil, and hydraulic hoses on Cessna 100, 200, 300, and 400 series airplanes. This kind of deterioration eventually causes the rubber hose to collapse, which could result in failure of the fuel, oil, or hydraulic systems.

NOTE 2: Figure 1 of this AD is included to show the diagonal or spiral external reinforcement wrap on the hose that is referenced in the check required by paragraph (b) of this AD.

OLD STYLE S51-10 HOSE  
WITH REINFORCEMENT  
WRAPPED IN ONLY ONE  
(DIAGONAL) DIRECTION THE  
LENGTH OF THE HOSE  
(REMOVE AND REPLACE WITH  
REPLACEMENT STYLE HOSE)

(c) Prior to further flight after the check required by paragraph (b) of this AD, replace any Cessna P/N S51-10 that has a diagonal or spiral pattern external reinforcement wrap with a Cessna P/N S51-10 hose that has a criss-cross pattern external wrap. Accomplish this replacement in accordance with the ACCOMPLISHMENT INSTRUCTIONS of the applicable service bulletin in paragraph (b) of this AD.

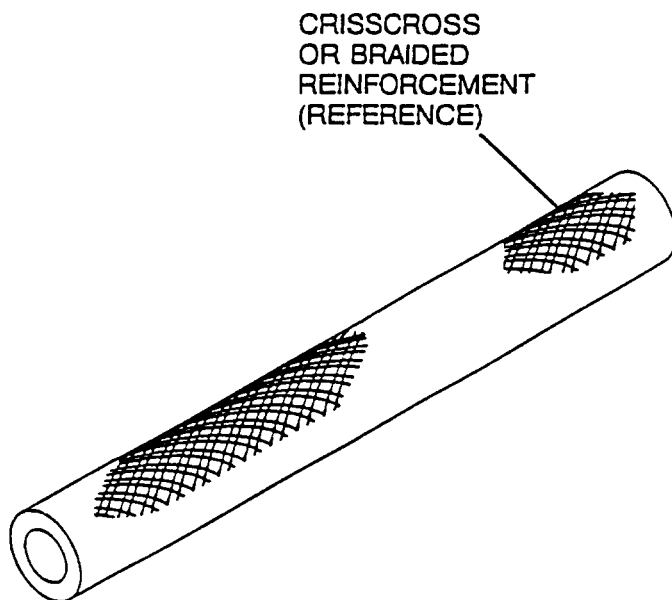
REPLACEMENT STYLE S51-10  
HOSE WITH A CRISS-CROSS  
OR BRAIDED REINFORCEMENT  
PATTERN
